Model: Moto Guzzi V85 TT Euro 5

Subject: Intake valve - Technical update

Campaign Code: PG2ZZQ2103

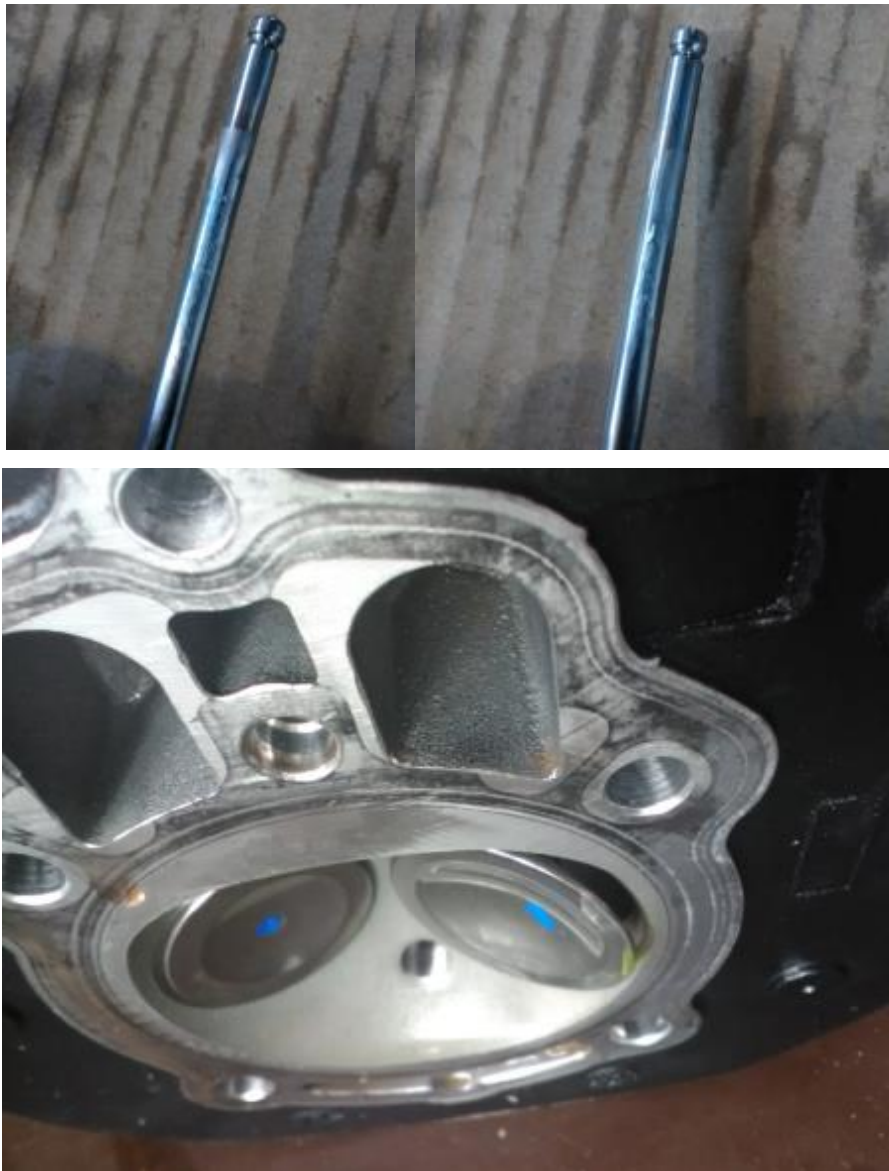
PHOTOS RELATIVE TO THE VALVE SEIZURE

- Disassemble the head, release the intake valve and remove it from the head.
- Check for any signs of incipient seizure and adhesion by moving the valve without load inside the respective valve guide (see photos below).
- Only in the event that there are possible signs on the stem and/or traces of incipient seizure, replace the entire head in question.
- If, on the other hand, none of the above aspects have occurred, replace the intake valve only, without replacing the head.

By way of example, some photos are shown below in order to unequivocally identify possible incipient seizure of the valve stem in its seat, first and second photos, while in the third photo the adhesion, without load, of the valve stem in its seat is appreciable.

If, on the other hand, the valve stem is damaged (**attach photo**), the entire head will need to be replaced.
