Model: Moto Guzzi V85 TT Euro 5

Subject: Intake valve – Technical update

Campaign Code: PG2ZZQ2103_KIT_PGA

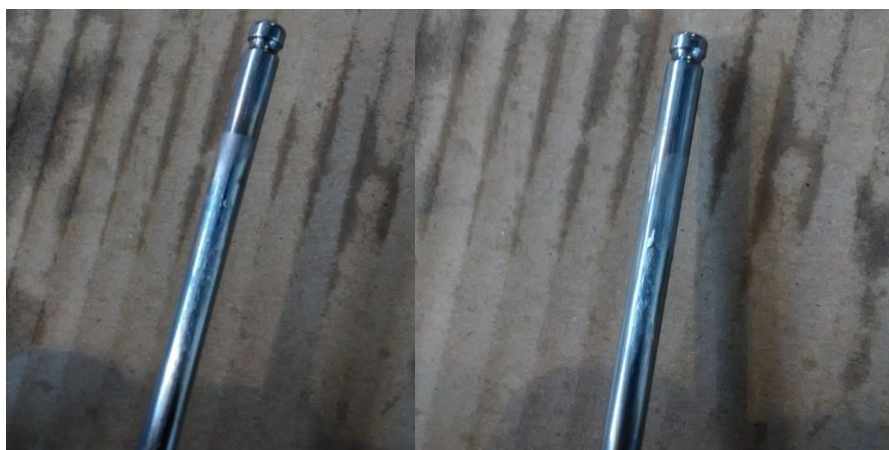
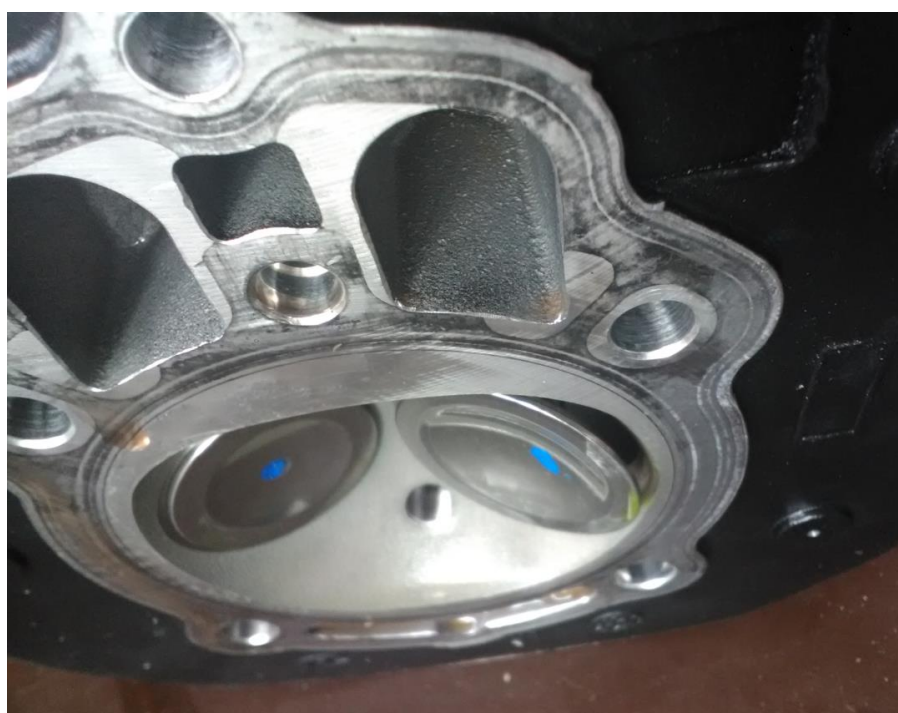
PHOTOS RELATIVE TO THE VALVE SEIZURE

- Disassemble the head, release the intake valve and remove it from the head.
- Check for any signs of incipient seizure and adhesion by moving the valve without load inside the respective valve guide (see photos below).
- Only in the event that there are possible signs on the stem and/or traces of incipient seizure, replace the entire head in question.
- If, on the other hand, none of the above aspects have occurred, replace the intake valve only, without replacing the head.

By way of example, some photos are shown below in order to unequivocally identify possible incipient seizure of the valve stem in its seat, first and second photos, while in the third photo the adhesion, without load, of the valve stem in its seat is appreciable.

If, on the other hand, the valve stem is damaged, the entire head will need to be replaced.
