Model: V85 TT Euro 5

Subject: workshop procedure for resolving irregular idle issue - video tutorial

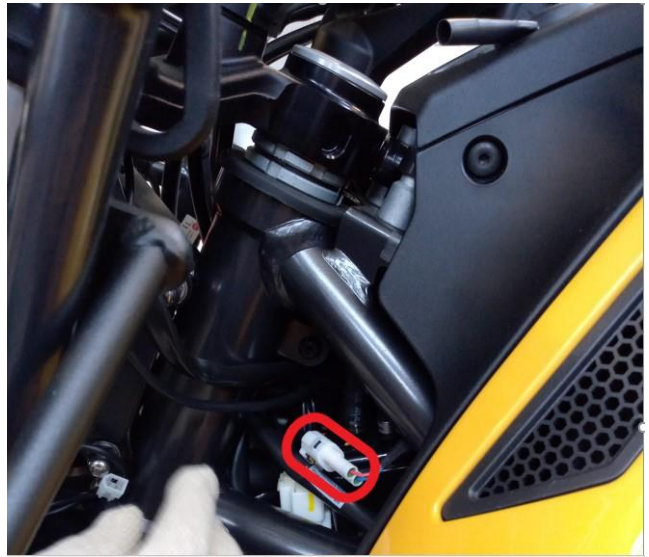
The irregular idle issue is caused by an incorrectly placed connector of the pick-up.

If the engine pick-up connector is in the incorrect position (as shown in the photo), reposition it correctly.

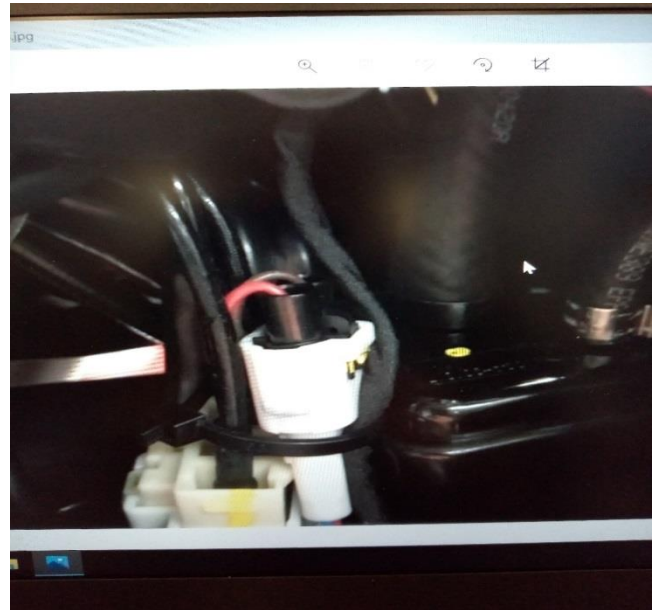
Correct definitive position.
