Model: V85 TT

Subject: new engine ECU calibration

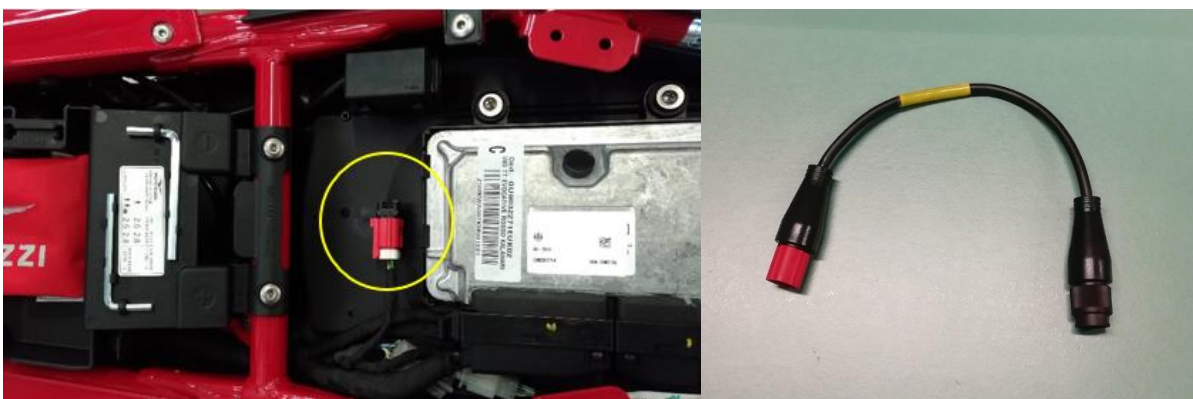
Photo 1. Position of the EOBD Euro5 diagnostic connector to which the cable code 021017Y is connected

Please note that to update the engine ECU software for the models in question, you must use the EOBD moto Euro5 accessory cable of the P.A.D.S. diagnostic tool **code 0210171Y** (see photo 1) and update the P.A.D.S. diagnostic tool to the latest available release.

- With the key in the OFF position, connect the cable code 021017Y to the red EOBD moto Euro5 diagnostic connector in photo 1, located under the seat.
- Turn the ignition switch to ON.
