Subject: NHTSA Recalls and Technical updates- V85TT

Affected Models: A select range of: **Moto Guzzi V85TT models**

PGJZZQ1904 “Installation of the Gearbox Cover” (The Final drive oil seal/cover)

PGJZZQ1905 “Foot peg circlips” (Foot peg retaining clips)

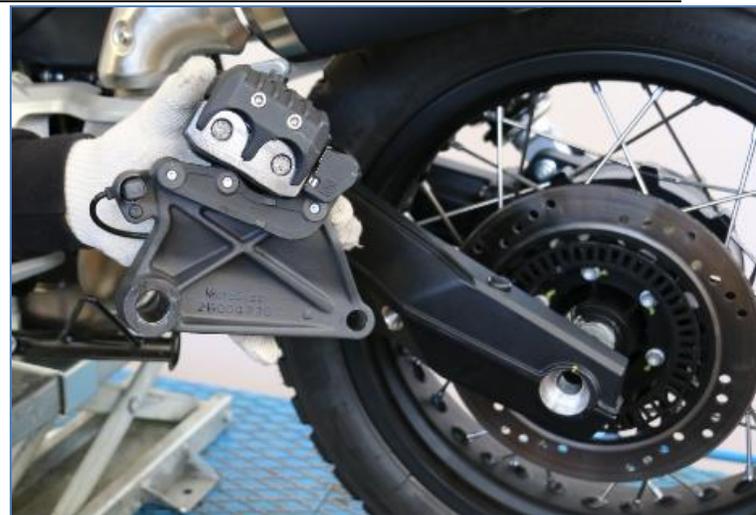
Important: If oil leaks are noted from the flexible coupling area, before continuing with the installation of the seal/cover kit, remove the breather and disassemble the final drive to replace the GU90413850 (inner small seal), 2B002535 (hub seal) and GU90706958 (case O-ring) Refer to the vehicle workshop manual for instructions.

Refit the breather only after having assembled the bevel gear on the vehicle and after blowing it with compressed air.

Enter a **normal warranty claim** specifying that the leak was detected during the campaign operation and enter campaign code "**PGJZZQ1904**"-Final drive oil leak" in the notes on the claim.

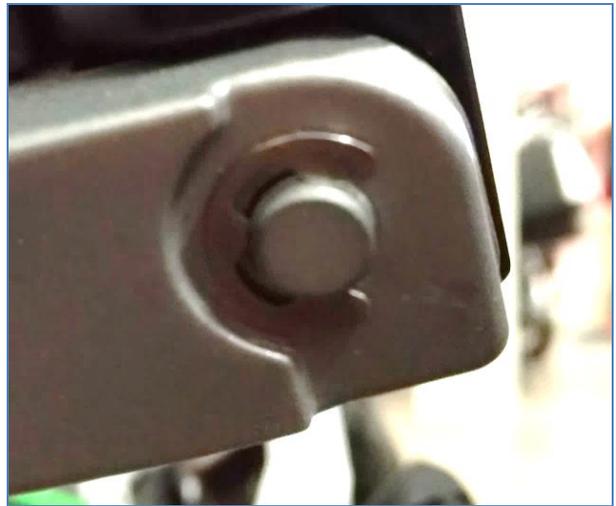
Check that the retaining circlips are inserted correctly in the slot of the rider and passenger footpeg pins; If all are correctly inserted, select coupon 1 for check only.

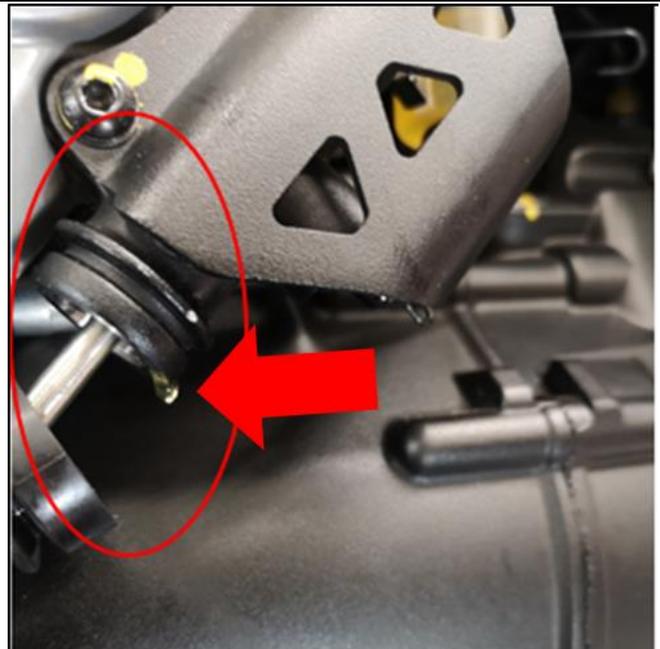
After manually removing the rear brake master cylinder's dust boot, check for the presence of brake fluid (see example in the photo on the side):

- Select the labor reimbursement **Coupon 1 for checking only- if no brake fluid is detected;**
- Select the labor reimbursement **Coupon 2 for checking and replacement** of the rear brake master cylinder **code 2B000508**, if you notice brake fluid leaks (see photo 1). **Claim entry automatically orders the part.**

Important : Do not confuse any assembly grease with brake fluid
