Model: V85 TT

Subject: instrument cluster calibration update

Piaggio & C. SpA

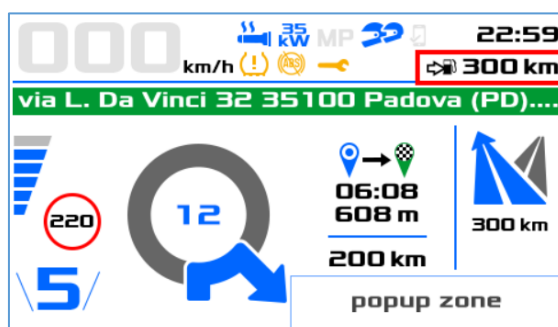
We hereby inform you that a new instrument cluster calibration dedicated to the model in question, is available by downloading it from the P.A.D.S. (update the instrument to the latest version available), which solves a problem concerning the non-update of the remaining fuel range value when on the NAVI page (see detail in red on the photo below).

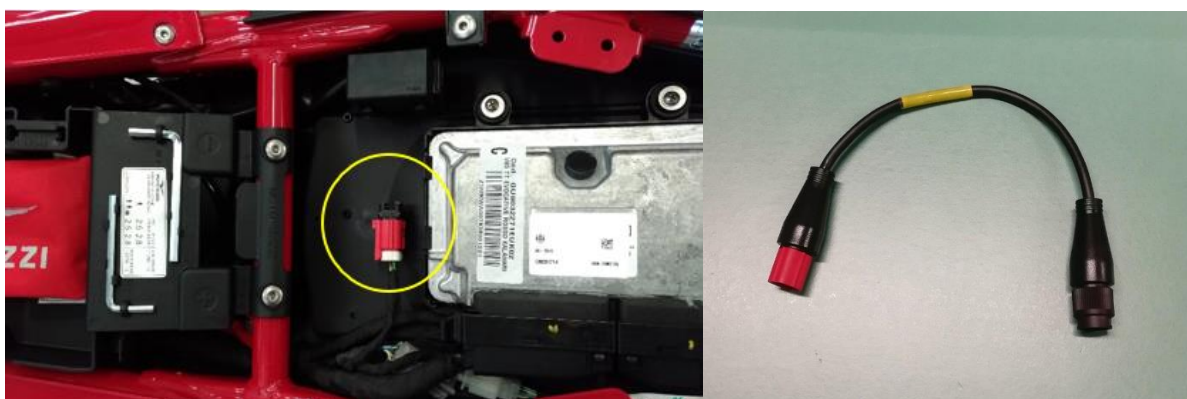
Photo 1 Position of the EOBD Euro5 diagnostic connector to which the cable code 021017Y is connected

Please note that to update the instrument cluster software for the models in question, you must use the EOBD moto Euro5 accessory cable of the P.A.D.S. diagnostic tool **code 021017Y** (see photo 1) and update the P.A.D.S. diagnostic tool to the latest available release.
