Model: V85 TT/Travel Euro 4

Subject: incorrect fuel level readings

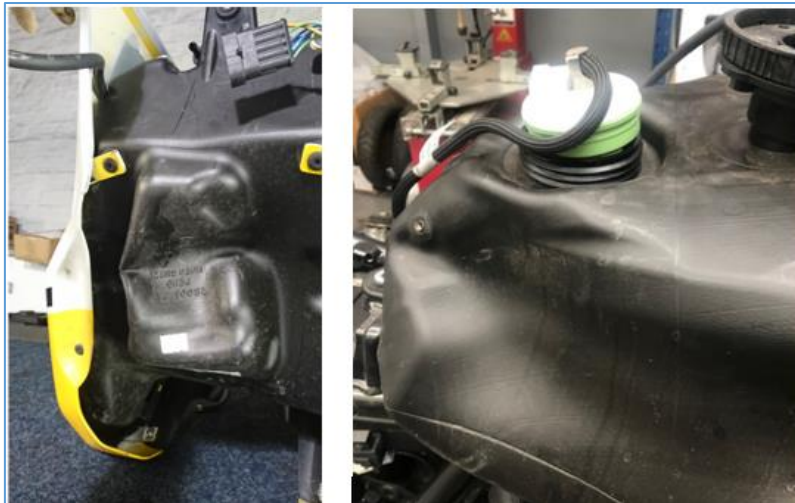
Photo 1

1. **Remove fuel tank completely and check for deformation of lower part or left/right hand lateral sides of the tank itself (see example in photo 1).** If any deformation is noted, open a request for replacement of the fuel tank under warranty with a new component, attaching photos of the damage to the tank to the request (if vehicle is still covered by warranty).

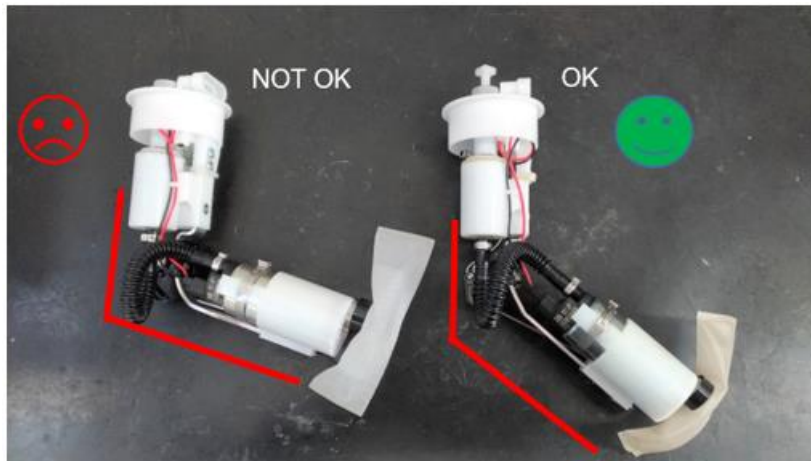
Photo 2

2. **Remove fuel pump and check if fuel level sensor arm is bent (see photo 2).** If the arm is found to be bent, open a request for replacement of the fuel pump under warranty with a new component, attaching photos of the bent arm to the request (if vehicle is still covered by warranty).

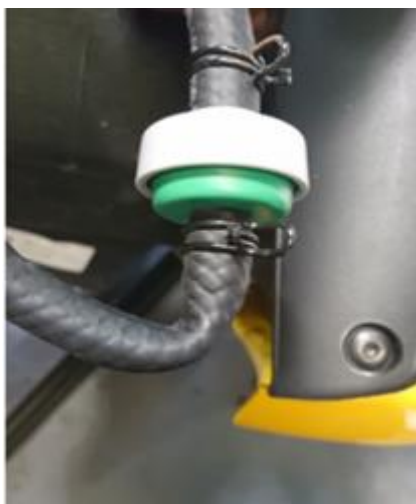
Photo 4

The pipe may be kinked after removing and refitting the fuel tank, impeding the correct flow of air regulated by the valve shown in photo 4.

3. Fit the pipe reinforcement P/N 2B007930, available from the spare parts catalogue, to the fuel tank vent pipe, as shown in photos 3 and 4.
