Subject: NHTSA Recalls and Technical updates- V85TT

Affected Models: A select range of: **Moto Guzzi V85TT models**

PGJZZQ1904 “Installation of the Gearbox Cover” (The Final drive oil seal/cover)

PGJZZQ1905 “Foot peg circlips” (Foot peg retaining clips)

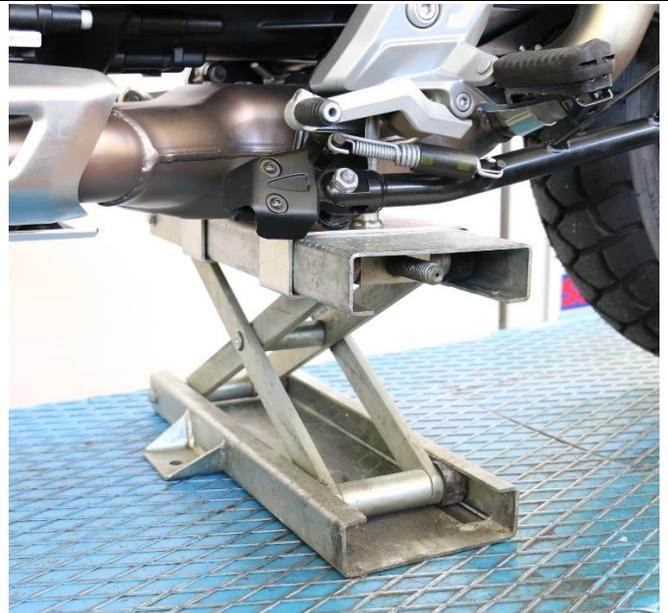
Important: If oil leaks are noted from the flexible coupling area, before continuing with the installation of the seal/cover kit, remove the breather and disassemble the final drive to replace the GU90413850 (inner small seal), 2B002535 (hub seal) and GU90706958 (case O-ring) Refer to the vehicle workshop manual for instructions.

Remove the rear wheel after removing the caliper support, without disconnecting the brake hose.
